Flooding, flood risks and coping strategies in urban informal residential areas: The case of Keko Machungwa, Dar es Salaam, Tanzania

This article presents findings from a study carried out in Keko Machungwa informal settlement in Dar es Salaam under the auspices of the Disaster Management Training Centre of Ardhi University, Tanzania. The settlement has experienced frequent flooding in the past five years, and this study explores the causes, risks, extent of flooding and coping strategies of residents as well as municipality and city officials. Key methods employed in capturing empirical evidence included mapping of zones by severity of flooding, interviews with households, subward leaders, and municipal and city officials. Non-participant observation, primarily taking photographs, complemented these methods. Laboratory tests of water samples taken from shallow wells in the settlement were performed to establish the level of pollution. In addition, records of prevalence of water-borne diseases were gathered from a dispensary within the settlement to corroborate flooding events, water pollution and occurrence of such diseases. Findings show that flooding is contributed to by the la

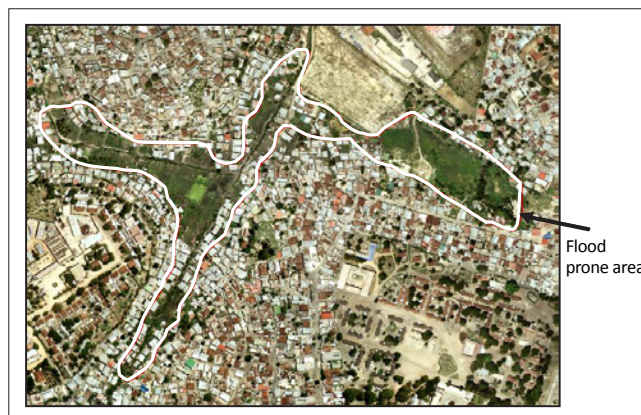
Although about 75% of the settlement does not experience flooding, the rest of the area can be subdivided into (1) most severely flooded and (2) moderately flooded areas. The most seriously affected area of the settlement is that between one and two metres above mean sea level. A topographic analysis of the settlement showed that this area covered 5.07 hectares,

which constituted 16.37% of the total study area (see Figure 1). There were 76 houses in this area. During the peak hours of flooding water reaches a height of half to one metre above the ground floor. During the rainy season the area gets filled up with water from within and outside Keko Machungwa. The water seriously affects houses built along the valley. The area that was moderately flooded covers 2.84 hectares and lies between two and four metres above mean sea level. There were 130 houses in this area.

FIGURE 1: Aerial photo showing flood-prone areas.

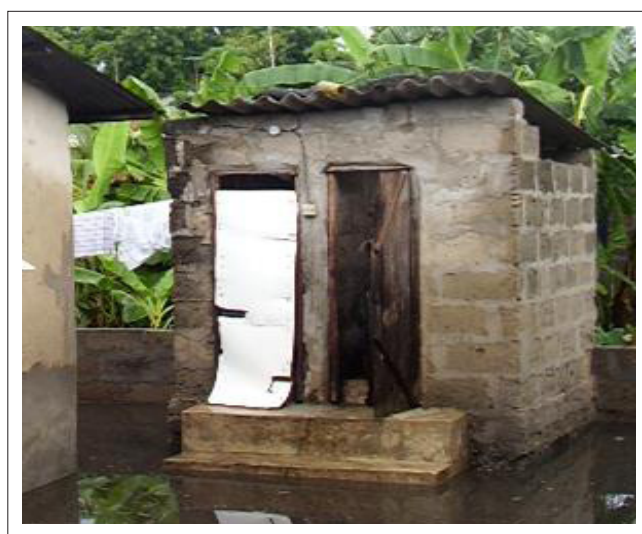
Household interviews conducted in the settlement have shown that 90% of the houses use pit latrines for sanitation. The combination of a high water table and the use of pit latrines results in frequent filling up of the pits when it rains heavily (see Figure 2).

Waste water from pit latrines becomes a serious health hazard during the rainy season, because people also empty their pit latrines into the flooding water. In this way human excreta spread throughout the settlement. Since several households use underground water for domestic purposes, they are likely to be vulnerable to water-borne related diseases such as cholera, malaria and bilharzia.

FIGURE 2: A pit latrine surrounded by stagnant water during rainfall season.

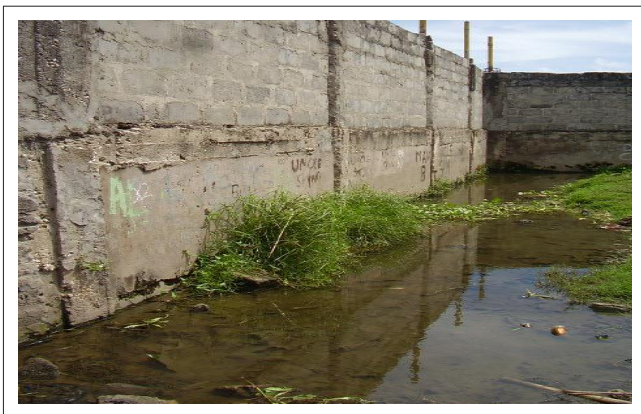
Haphazard construction of warehouses and housing has aggravated flooding in Keko Machungwa. Examples of this phenomenon are warehouses built by Ruby Road Ways and Oil Com Company. Ruby Road Ways has constructed a warehouse across the Keko stream, leaving a small hole for stormwater. Similarly, Oil Com Company has reclaimed part of the river valley by filling up part of a plot with soil and then constructing a wall (see Figure 3).

The reclamation of land and construction of a wall necessitated shifting the river course from its original natural path towards residential areas. The partial blocking and shifting of the stream contributes substantially to flooding of the surrounding residential areas of Keko Machungwa.

FIGURE 3: Wall constructed by Ruby Road Ways on top of the stream, blocking the natural course of the river.

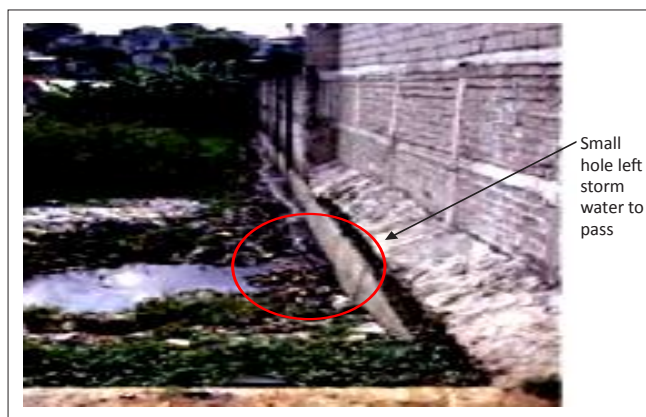
Although the owner of Ruby Road Ways provided a hole reinforced with some iron bars for stormwater to pass through, the size of the hole was too narrow to accommodate the huge volume of stormwater (see Figure 4).

As a result, when it rains heavily part of the stormwater flashes back to the settlement. The owner of the company explained that he had designed a small hole in order to prevent solid waste from entering his premises. In fact, when it rains heaps of uncollected solid waste accumulate and get deposited outside the wall. The accumulated waste completely blocks the hole, to the extent that stormwater can hardly pass through it. Therefore, the blocking of the natural drainage system and poor design and construction of the hole affect the majority of low-income people whose houses are in the severely flooded low-lying zone.

FIGURE 4: Wall constructed by Oil Com Company blocking natural water flow.

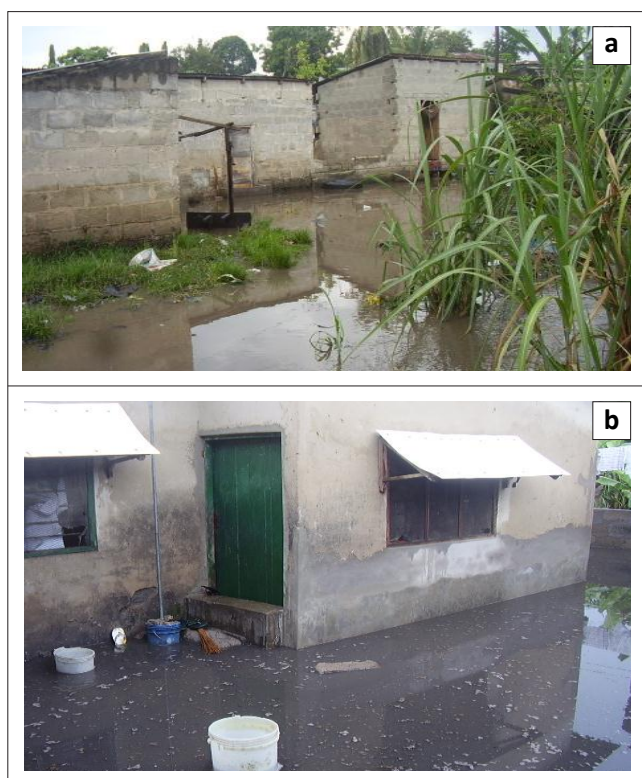
It was observed that waterlogging did not only occur in the severely and moderately flooded areas but also on the flat areas with congested houses and where drainage channels were non-existent. This resulted in the blocking of both vehicular and pedestrian accessibility to these houses (see Figure 5). Some residents passed through this water barefoot, fearing destroying their shoes, this action also likely to cause diseases.

FIGURE 5: Waterlogging (a) and blocked accessibility (b) to houses.

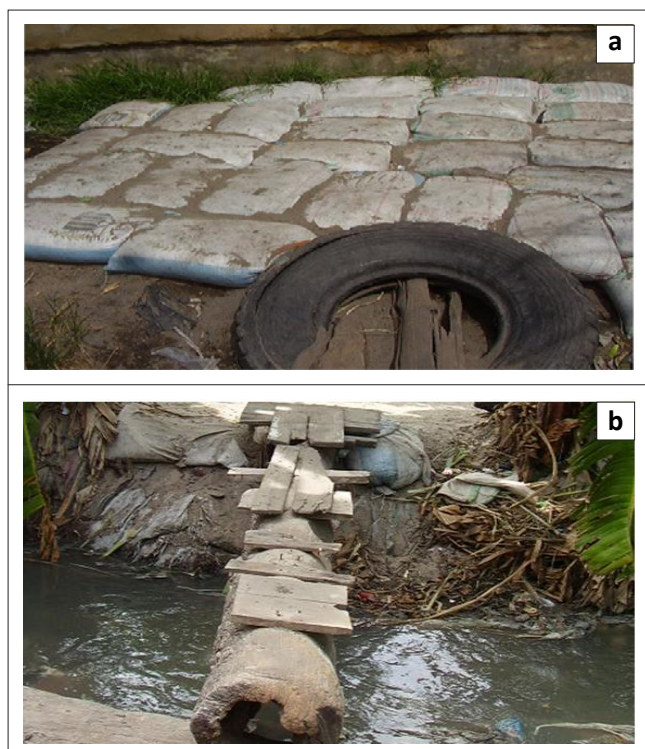
The use of sandbags was meant to prevent erosion, provide accessibility and block flooding water, whilst tree logs were used to construct footbridges (see Figure 6). This strategy was, however, not suitable to resist heavy stormwater from heavy rainfalls, because the sandbags and tree logs were always washed away. Of the 30 interviewed households, 24 reported having been using sandbags to prevent flooding water from entering their houses. Children and old people found it difficult to use footbridges made from tree logs.

FIGURE 6: Sandbags (a) used to prevent flooding and erosion (b).

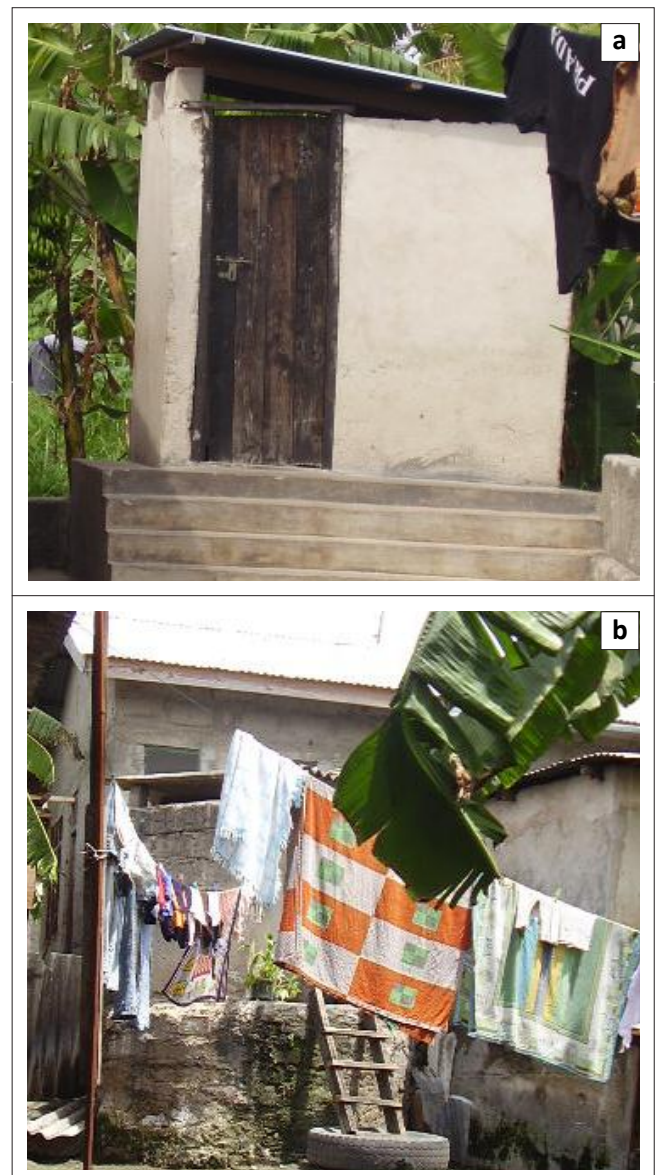
As a result of flooding and the fluctuating water table, most households raised their doorsteps and pit latrine steps to prevent the stormwater from filling up their houses and pit latrines. Of 30 interviewed households, 15 had raised doorsteps to their houses and 14 had their pit latrines raised one metre above the plinth level. It was, however, noted that this strategy was also inadequate to cope with severe flooding (see Figure 7).

FIGURE 7: (a) Pit latrines (b) raised from plinth level.

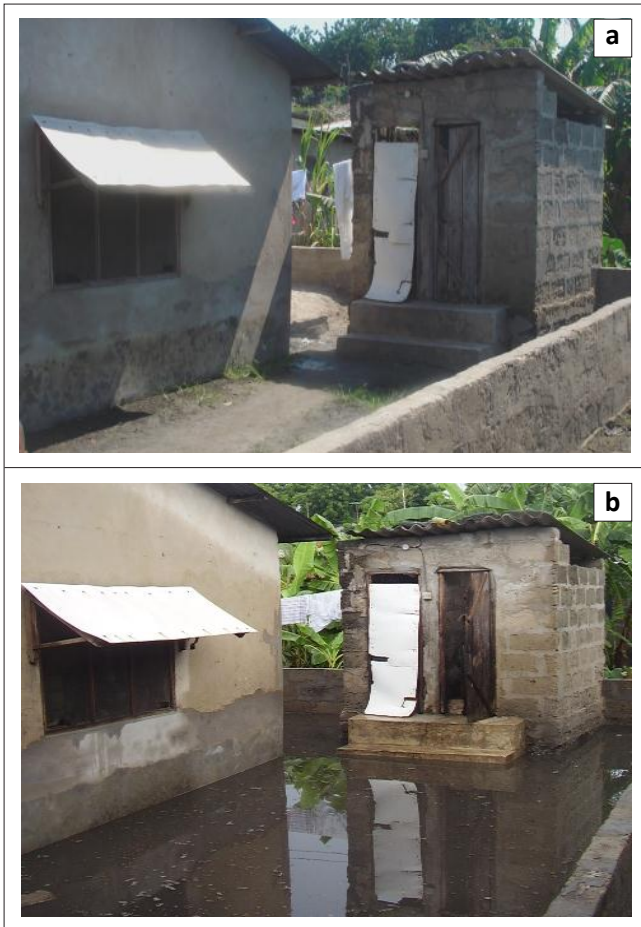
Wherever households had extra space around their houses, they built protective walls. Other households raised the foundation levels to prevent water from entering their houses. Although this solution helped individual houses, it largely blocked water flow during flooding. Also erosion caused some of the protective walls and houses to fall down. Protective walls were used by few households – only 6 out of the 30 interviewed. Since protective walls were constructed around the whole house flood water remained within the house compounds for long periods of time, resulting in other damage such as erosion of the foundations of buildings (see Figure 8).

FIGURE 8: Construction of protective walls (a) before rainfall and (b) after rainfall.

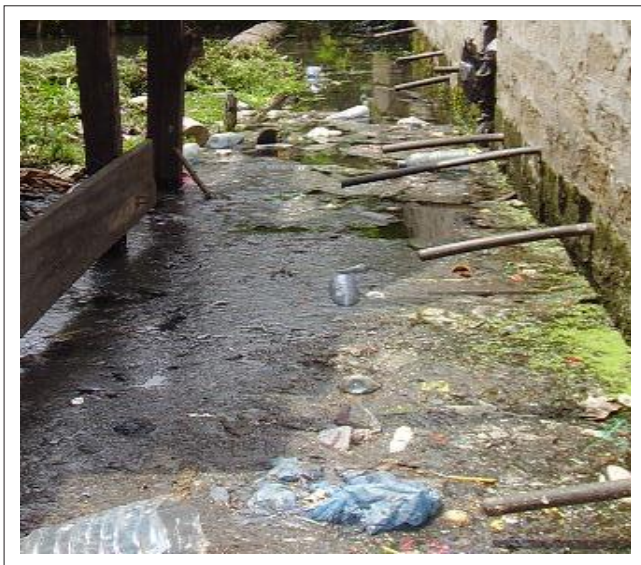
Water outlet pipes were built above the plinth level to drain off water. The most common pipes were of 20 mm – 50 mm in diameter. These outlets reduced water to a certain extent, because during heavy rainfalls water entered houses through doors and other wall openings (see Figure 9). Only one household out of 30 used this particular strategy.

FIGURE 9: Outlet pipes.
